TS-PIC-20202335S
May 2002

AERIAL PHOTOGRAPHIC ANALYSIS OF STANDARD CHLORINE CHEMICAL CORPORATION SITE Kearny, New Jersey

AERIAL PHOTOGRAPHIC ANALYSIS OF
STANDARD CHLORINE CHEMICAL CORPORATION SITE

Kearny, New Jersey

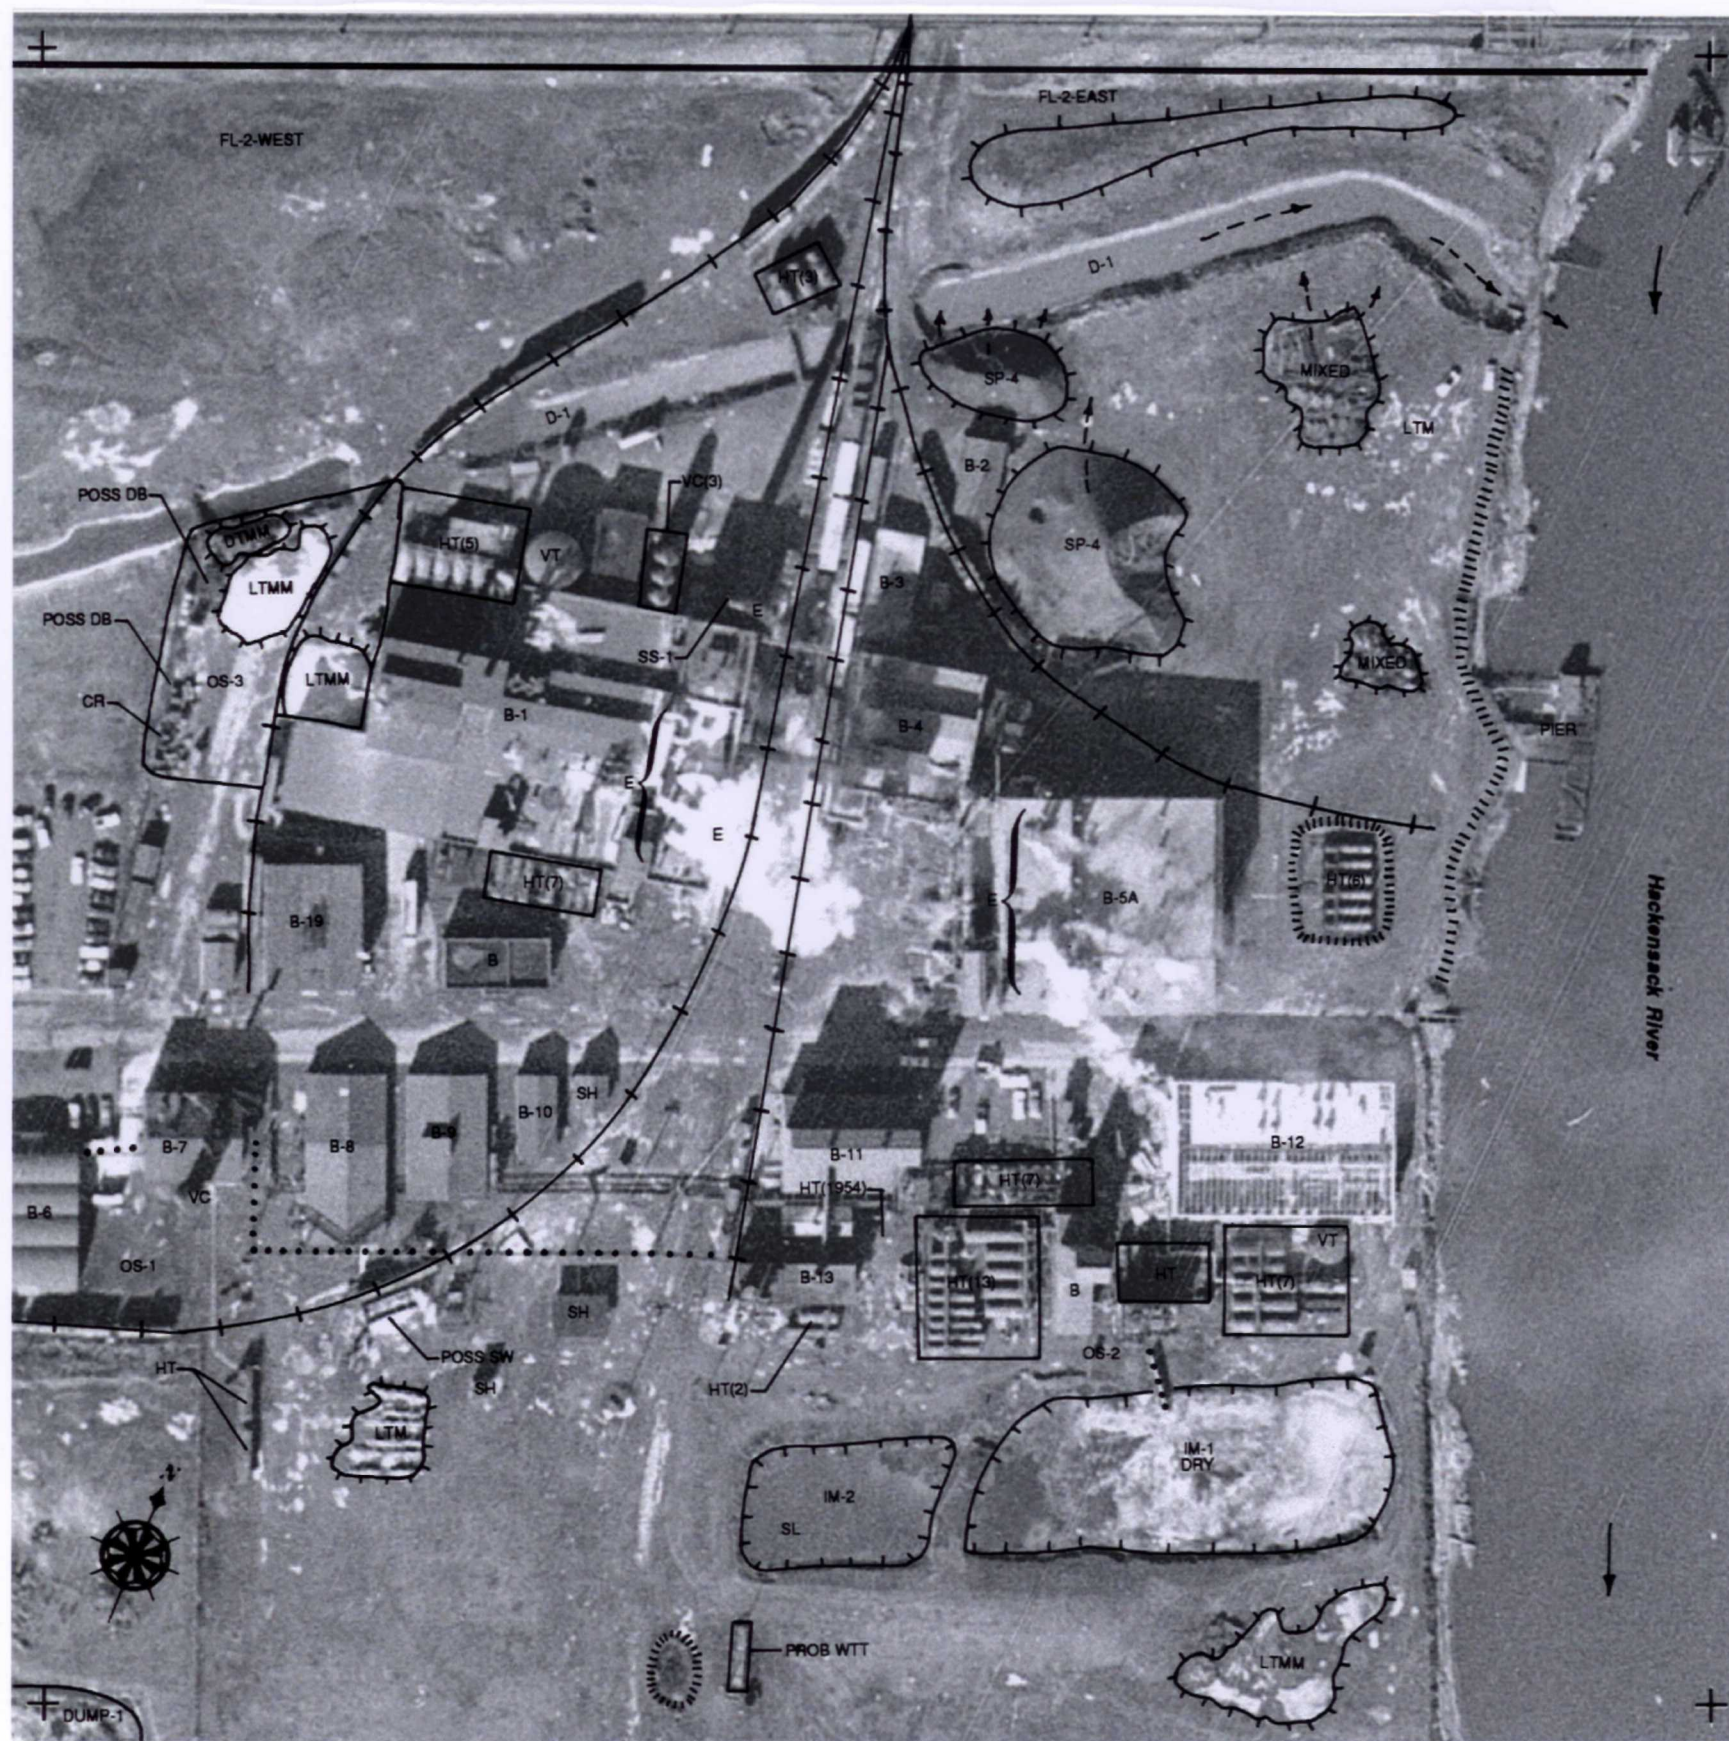
Three horizontal tanks have been installed north of building B-1 on the north side of drainage ditch D-1. The tanks appear to lack secondary containment. Potential spillage or leakage from these tanks is likely to drain into the adjacent ditch D-1.

Stockpile SP-1 noted on the north side of building B-1 in 1954 is absent. The light-toned emissions observed over the smokestacks on the roof of building B-1 and the tall smokestack SS-1 obscure the view of the southeast side of the building. Despite the smoke, railroad boxcars (not annotated) are observed on the tracks between buildings B-1 and B-4, on the spur east of building B-4, and on the spur west of building B-1.

Three vertical columns have been reinstalled along the north side of building B-1. Only five tanks are observed in the group of horizontal tanks at the northwest corner of building B-1 where six had been noted in 1954. No change is discerned in the group of seven horizontal tanks on the south side of this building. No spillage is evident around these tanks which appear to lack secondary containment structures.

toned mounded material have been deposited in the open area on the north and east sides of building B-2. Surface runoff from this portion of the plant drains into ditch D-1. An earthen, secondary containment berm is observed around the group of six horizontal tanks located to the east of building B-5A. The river pier in this portion of the site now appears to be derelict and the pipeline that connected the pier to building B-4 in 1954 is no longer observed.

No modifications are noted in the tank farms south of buildings B-11 and B-12; however, four of the horizontal tanks on the east side of building B-13 have been removed. Shadows obscure the view of several storage tanks so that a total tank count is not possible. The eastern portion of building B-11 has been dismantled and building B-12 appears to be under modification/renovation.

The large impoundment IM-1 has been partitioned with an earthen berm to form a second impoundment (IM-2). Impoundment IM-1 appears dry and contains a light-toned residue. A segment of pipe is visible entering impoundment IM-1 from the north. Impoundment IM-2 appears to contain light-toned liquid. Bottom-lining material could not be discerned in either of these impoundments. South of the impoundments is a rectangular structure that appears to be a probable wastewater treatment tank (WTT) and an accumulation of light-toned mounded material.

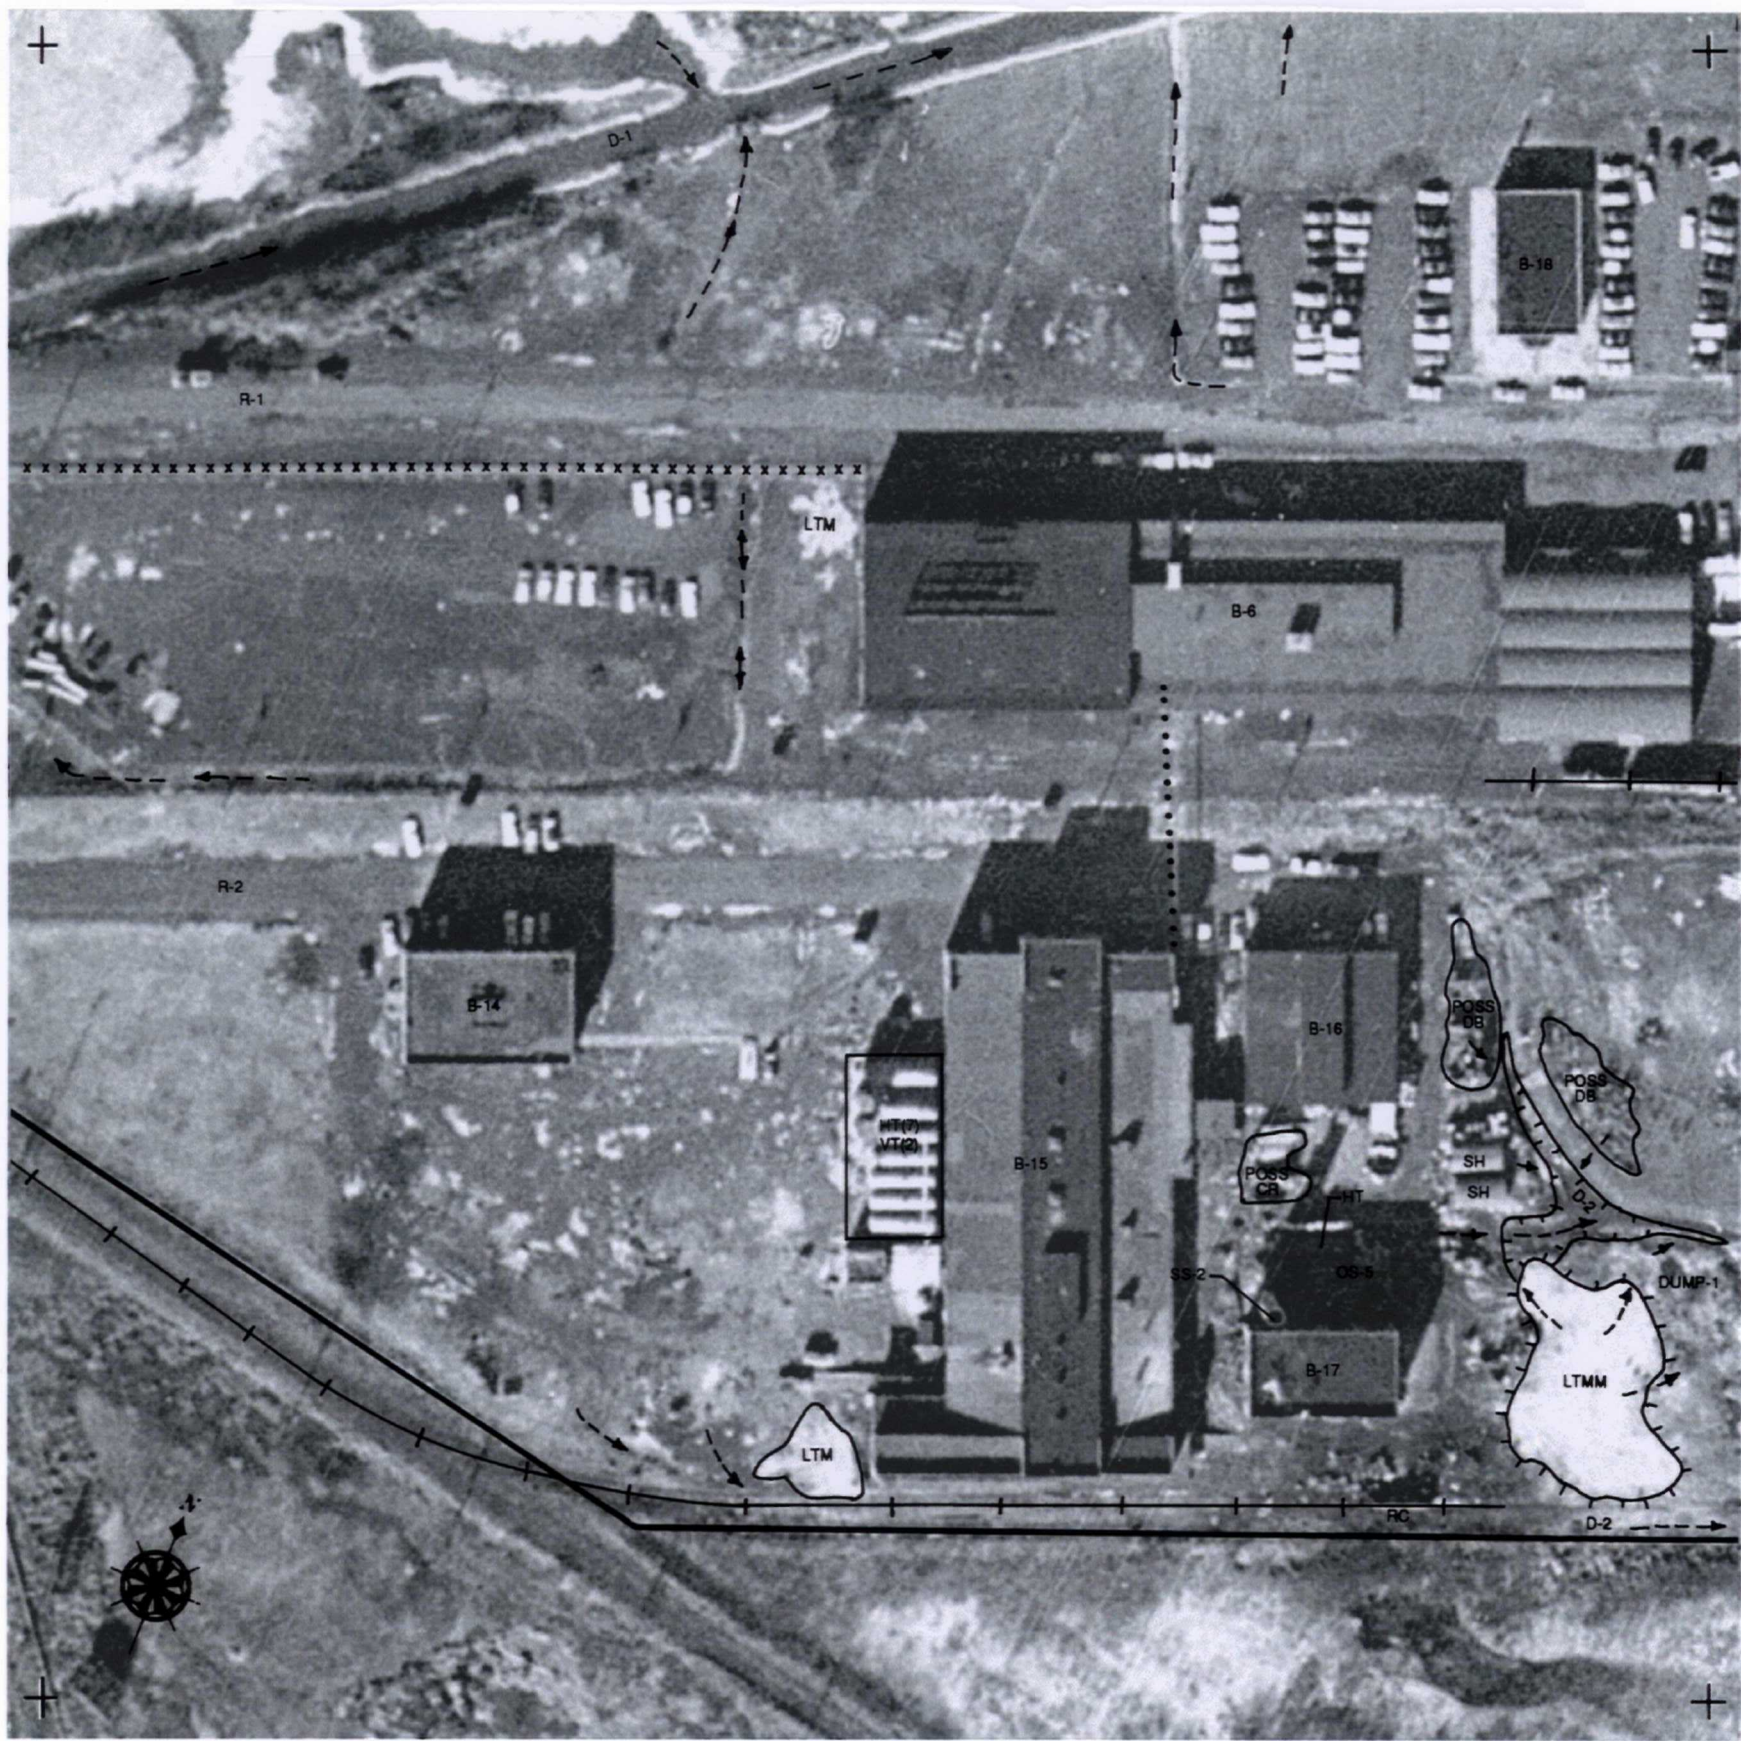
Buildings B-18 and B-6 in the central portion of the site do not appear to have been modified since 1954. Buildings B-14 through B-17 continue to be operational and one railroad tankcar is observed south of building B-17. Since 1954 two vertical and seven horizontal tanks have been installed on the west side of building B-15. These tanks do not appear to have secondary containment. Light-toned material is observed on the west side of building B-6 and at the southwest corner of building B-15. A storage area (OS-5) is observed between and east of buildings B-16 and B-17 which contains possible crates/boxes, possible debris, and light-toned material. Large accumulations of possible debris are piled just east of building B-16. One horizontal tank within a containment wall is observed on the north side of building B-17. Ditch D-2 receives runoff and possible discharges from buildings B-16 and B-17 and surface runoff from the storage area OS-5.

This figure shows in greater detail the open dump Dump-1 east of building B-17 where light-toned mounded material is clearly evident.

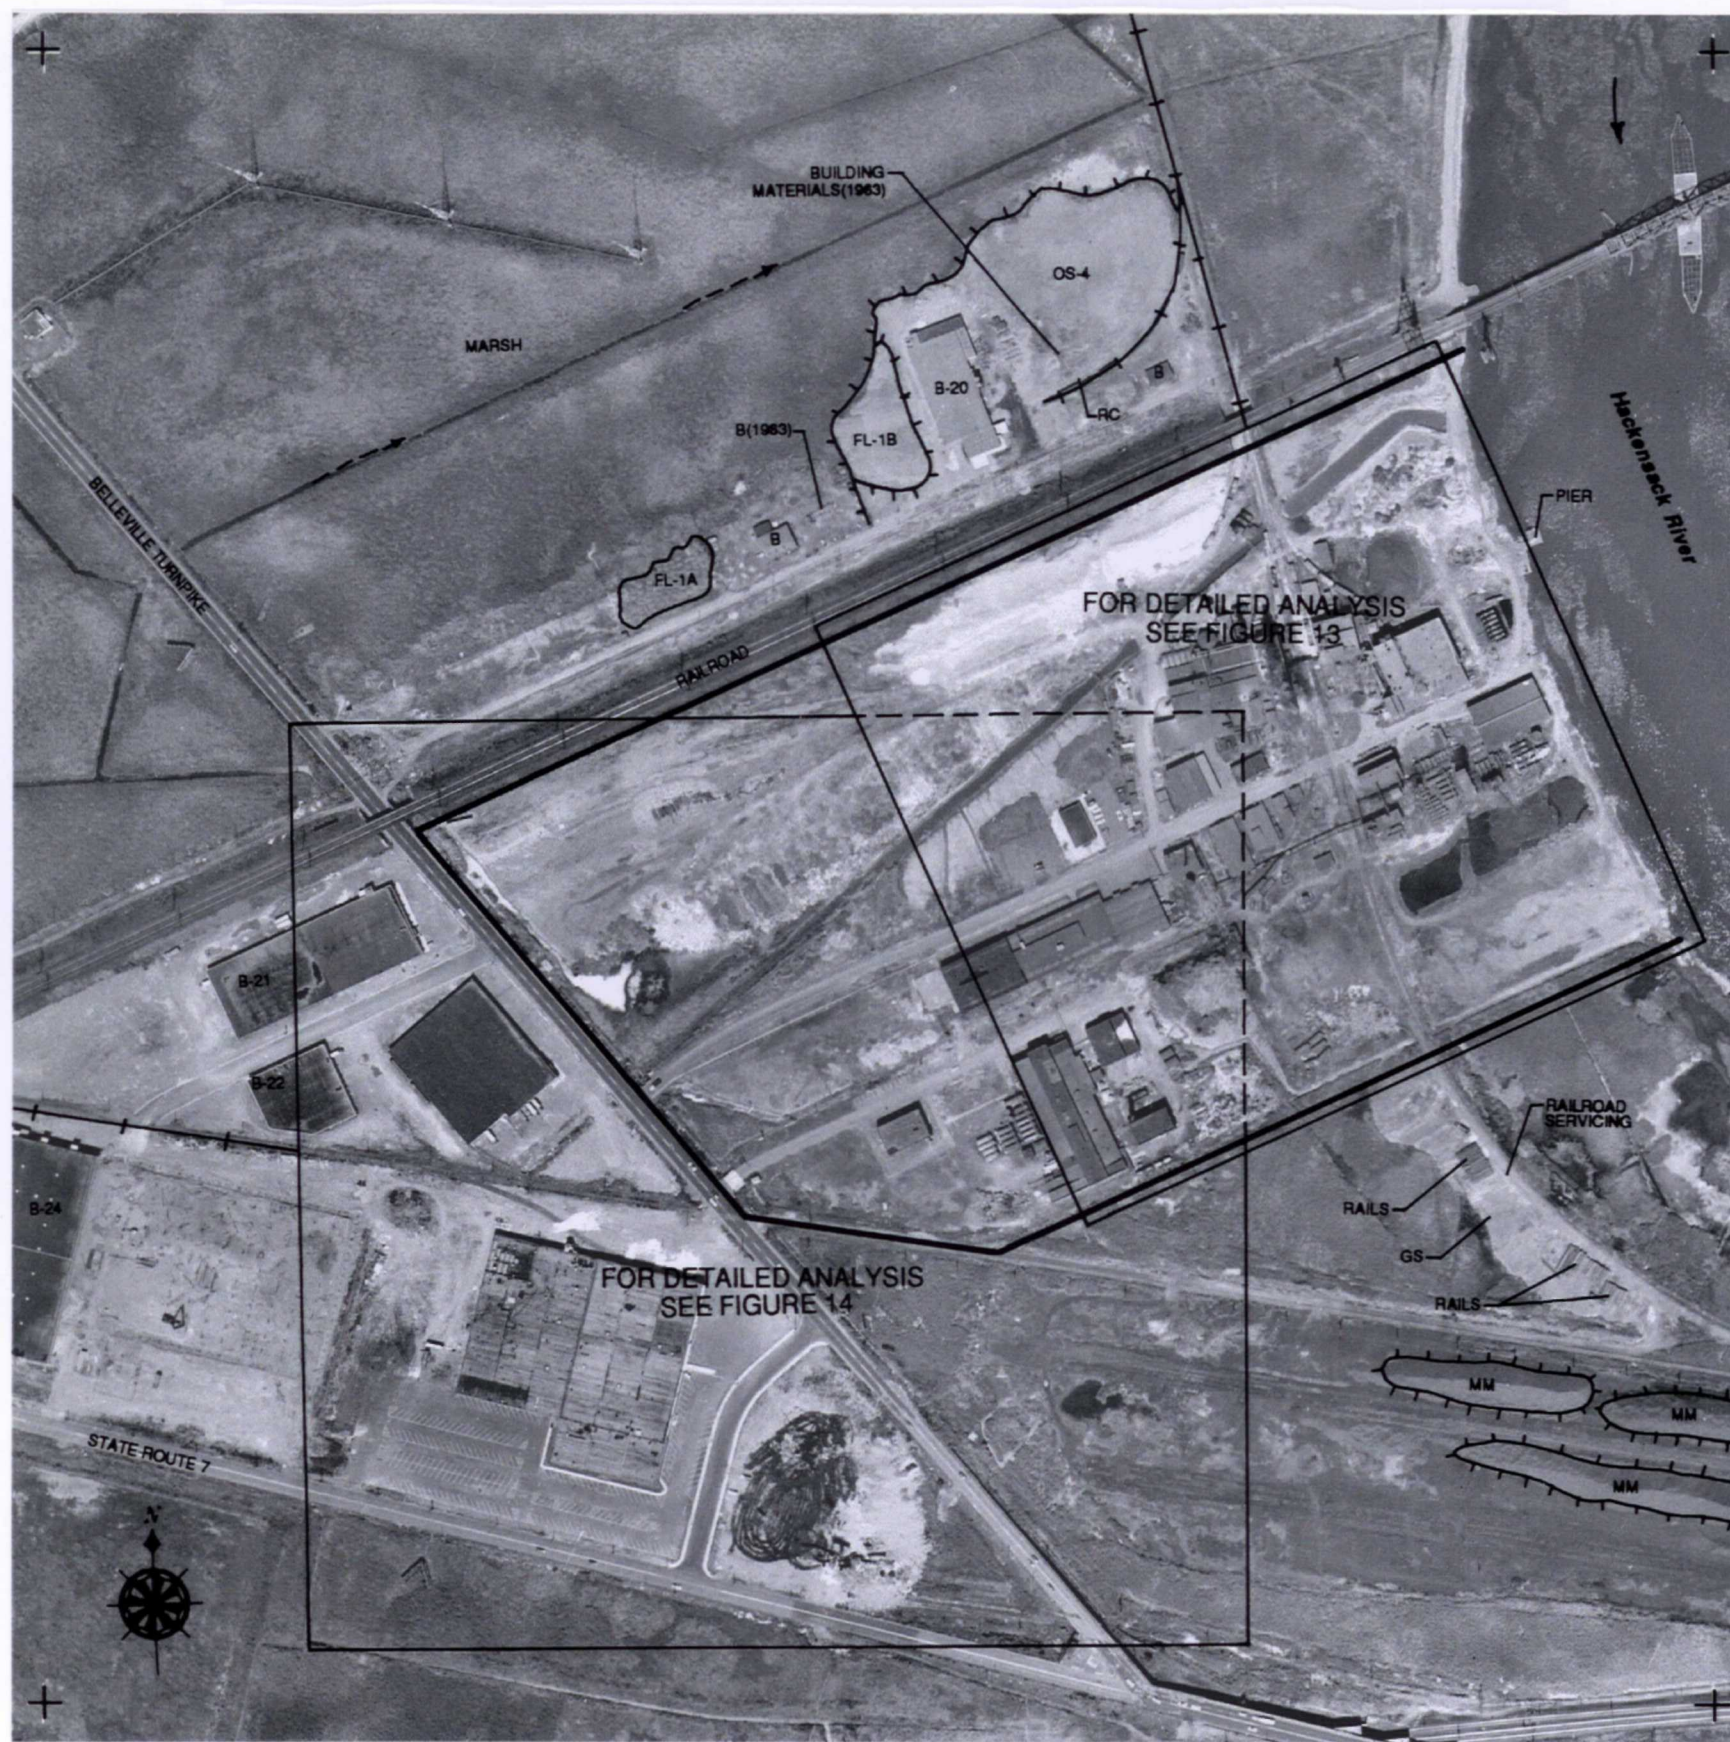
One of the buildings noted in 1963 on the north side of the railroad, in former fill area FL-1, has been removed and another large building (B-20) has been erected further east. Filling activity is evidenced by the mottled mound (FL-1A) and the larger mound (FL-1B) on the west side of the new building B-20. Fill has also been used to raise and level the west side of the open storage area OS-4. Fewer building materials are observed at area OS-4 compared to 1963 but the railroad spur that serves building B-20 appears unchanged.

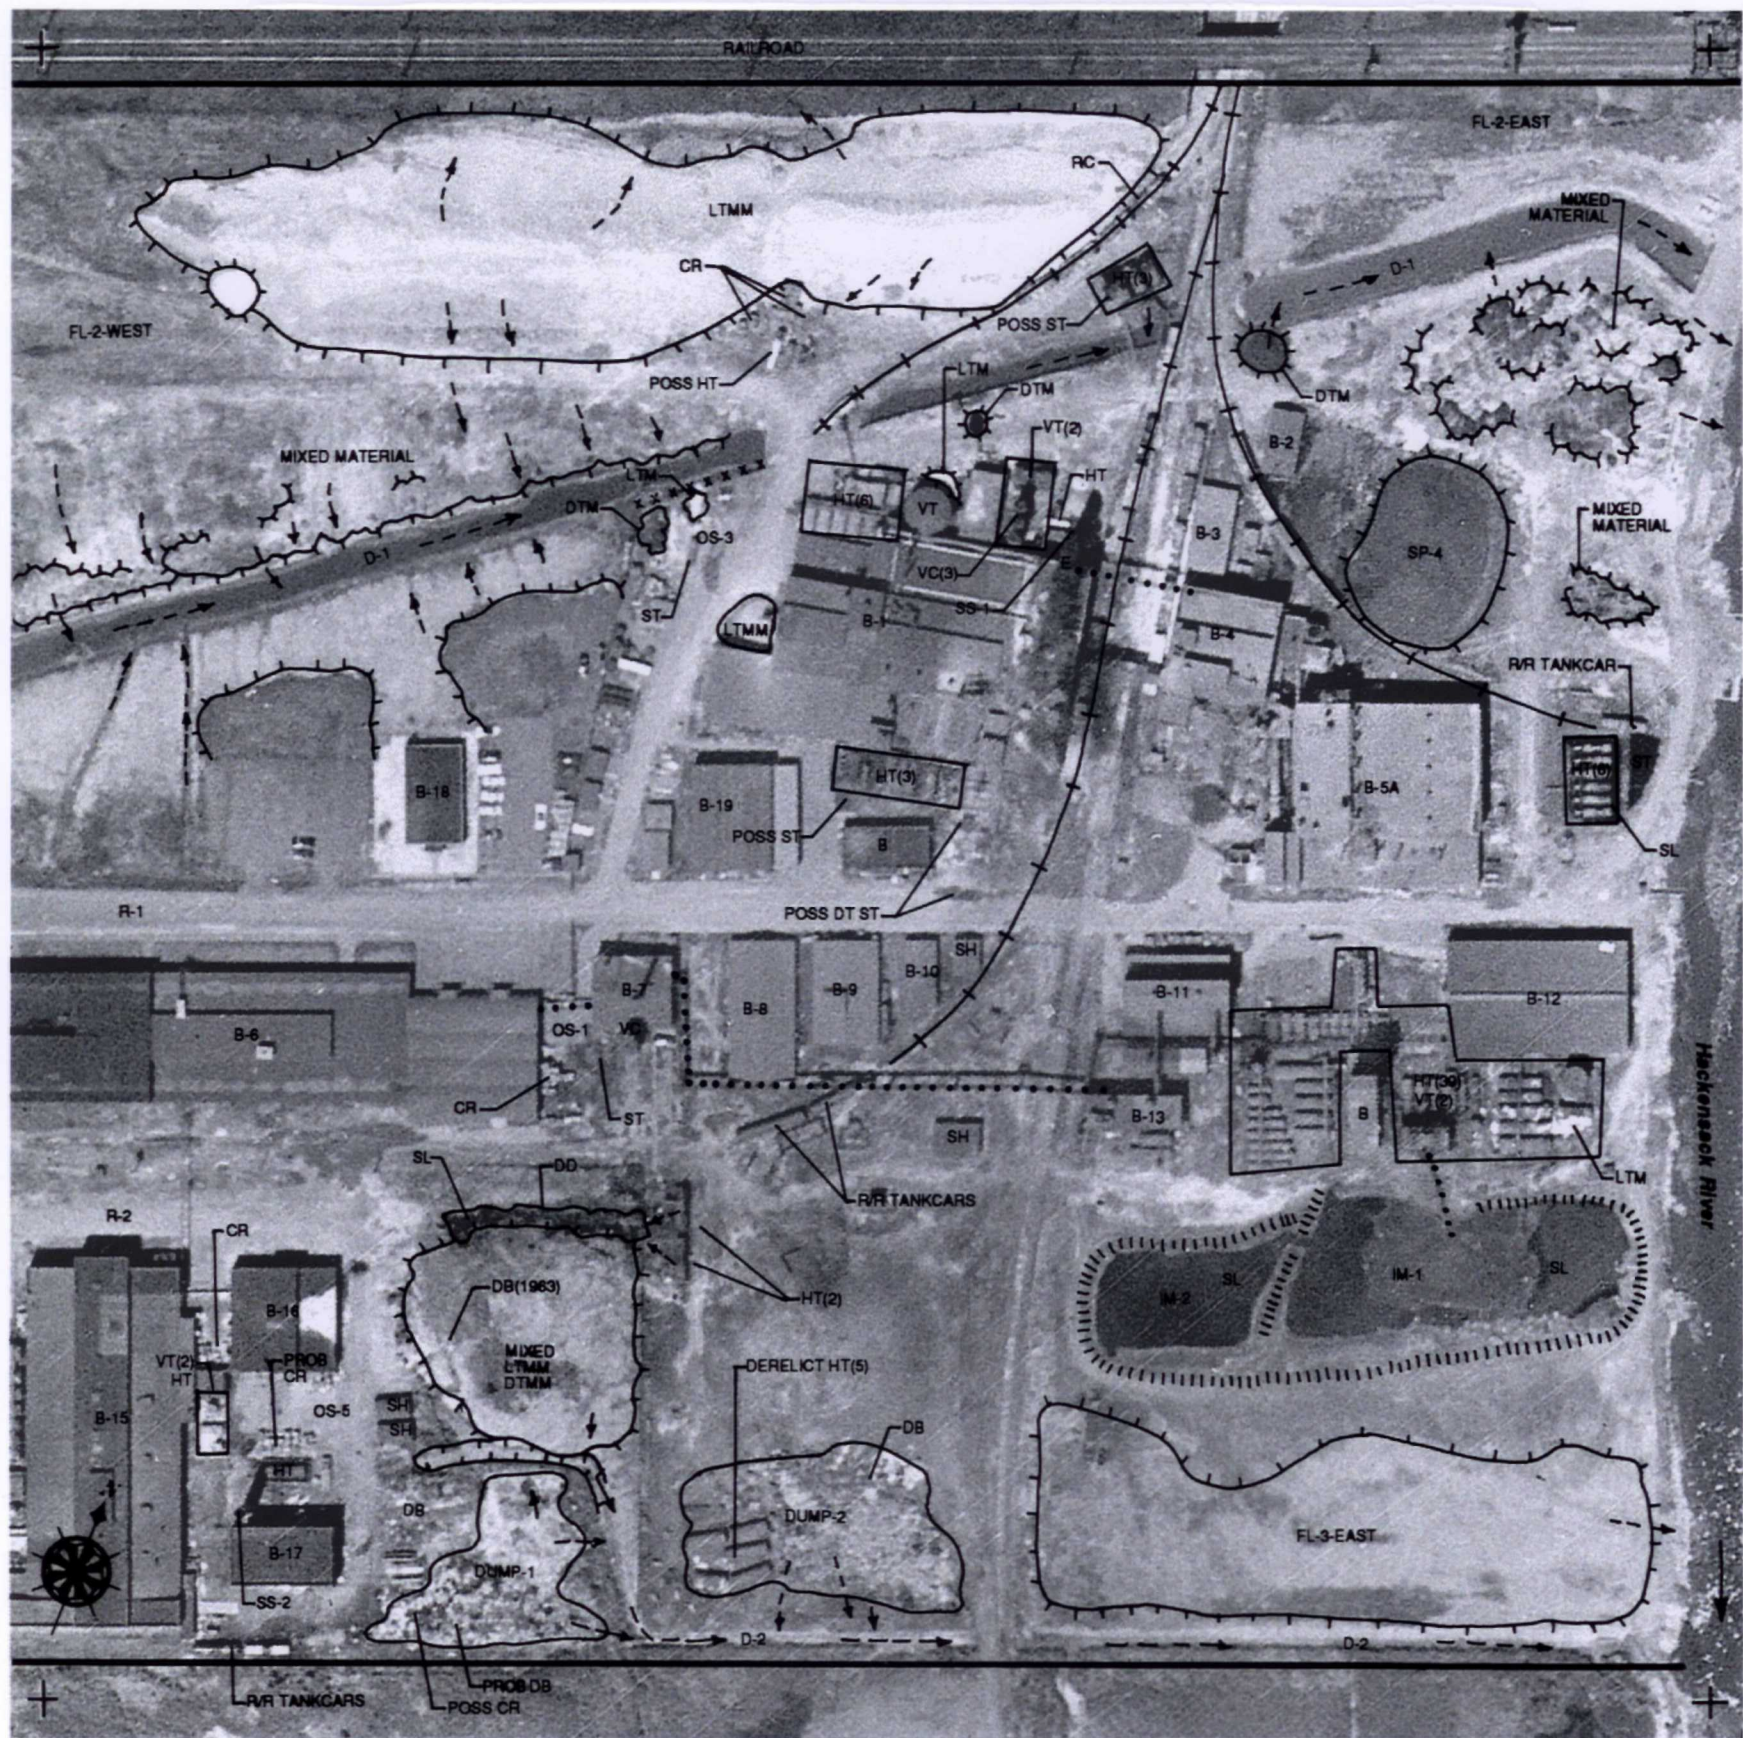
The three horizontal storage tanks, also on the north side of drainage ditch D-1, continue to appear operational and lack secondary containment. Dark-toned, possible ground staining is visible around these tanks and may indicate spillage or leakage. Rainwater runoff could transport potential contamination from the stained soil around these tanks into drainage ditch D-1.

Building B-1 remains operational. A dark-toned emission is visible coming from the tall smokestack SS-1 for the first time. Six horizontal tanks can be observed in a group at the northwest corner of building B-1 and no spillage or leakage is noted. A pile of light-toned material has been accumulated next to the large vertical tank on the north side of building B-1. Two medium-sized vertical tanks have been installed next to the three vertical columns on the north side of building B-1. A pile of dark-toned material is visible north of these vertical tanks.

It appears that four of the seven horizontal tanks observed in 1963 on the south side of building B-1 have been removed. Dark-toned, possible ground stains observed near the former location of these tanks are an indication that the tanks may have leaked.

The accumulation of light-toned mounded material noted in storage area OS-3 has been reduced in size compared to its appearance in 1963. However, area OS-3 contains both light- and dark-toned material and a ground stain. Surface runoff from this storage area drains into ditch D-1.

Buildings B-2 through B-5A do not appear to have been modified since 1963. The larger of the two stockpiles SP-4 noted in 1963 northeast of building B-4 is still visible. But only a pile of dark-toned material is present north of building B-2 where the other stockpile SP-4 was previously observed. Large deposits of mixed light- and dark-toned mounded material have been accumulated along the south side of ditch D-1. Potential contamination from these deposits would enter ditch D-1 and flow into the Hackensack River.

To the south, dark-toned liquid is visible inside the secondary containment wall around the six horizontal tanks situated east of building B-5A. The source of a dark-toned ground stain observed outside the east containment wall could be leakage from the containment wall or spillage/leakage/discharge from a lone railroad (R/R) tankcar at the north side of this stain.

Buildings B-6 through B-10 do not appear to have been modified since 1963. Boxes or crates are visible on the east side of building B-6 and a ground stain is noted between building B-6 and B-7. The two horizontal tanks south of building B-7 are adjacent to a large depression (DD). The dark-toned standing liquid in this depression could be leakage/spillage/discharge from the horizontal tanks. Between the depression DD and Dump-1 additional mixed light- and dark-toned material has been deposited.

Five derelict horizontal tanks are noted at the south end of Dump-2. Ditch D-2 receives runoff and possible discharges from buildings B-15 through B-17 in the southwest portion of the plant as well as runoff from both Dump-1 and Dump-2.

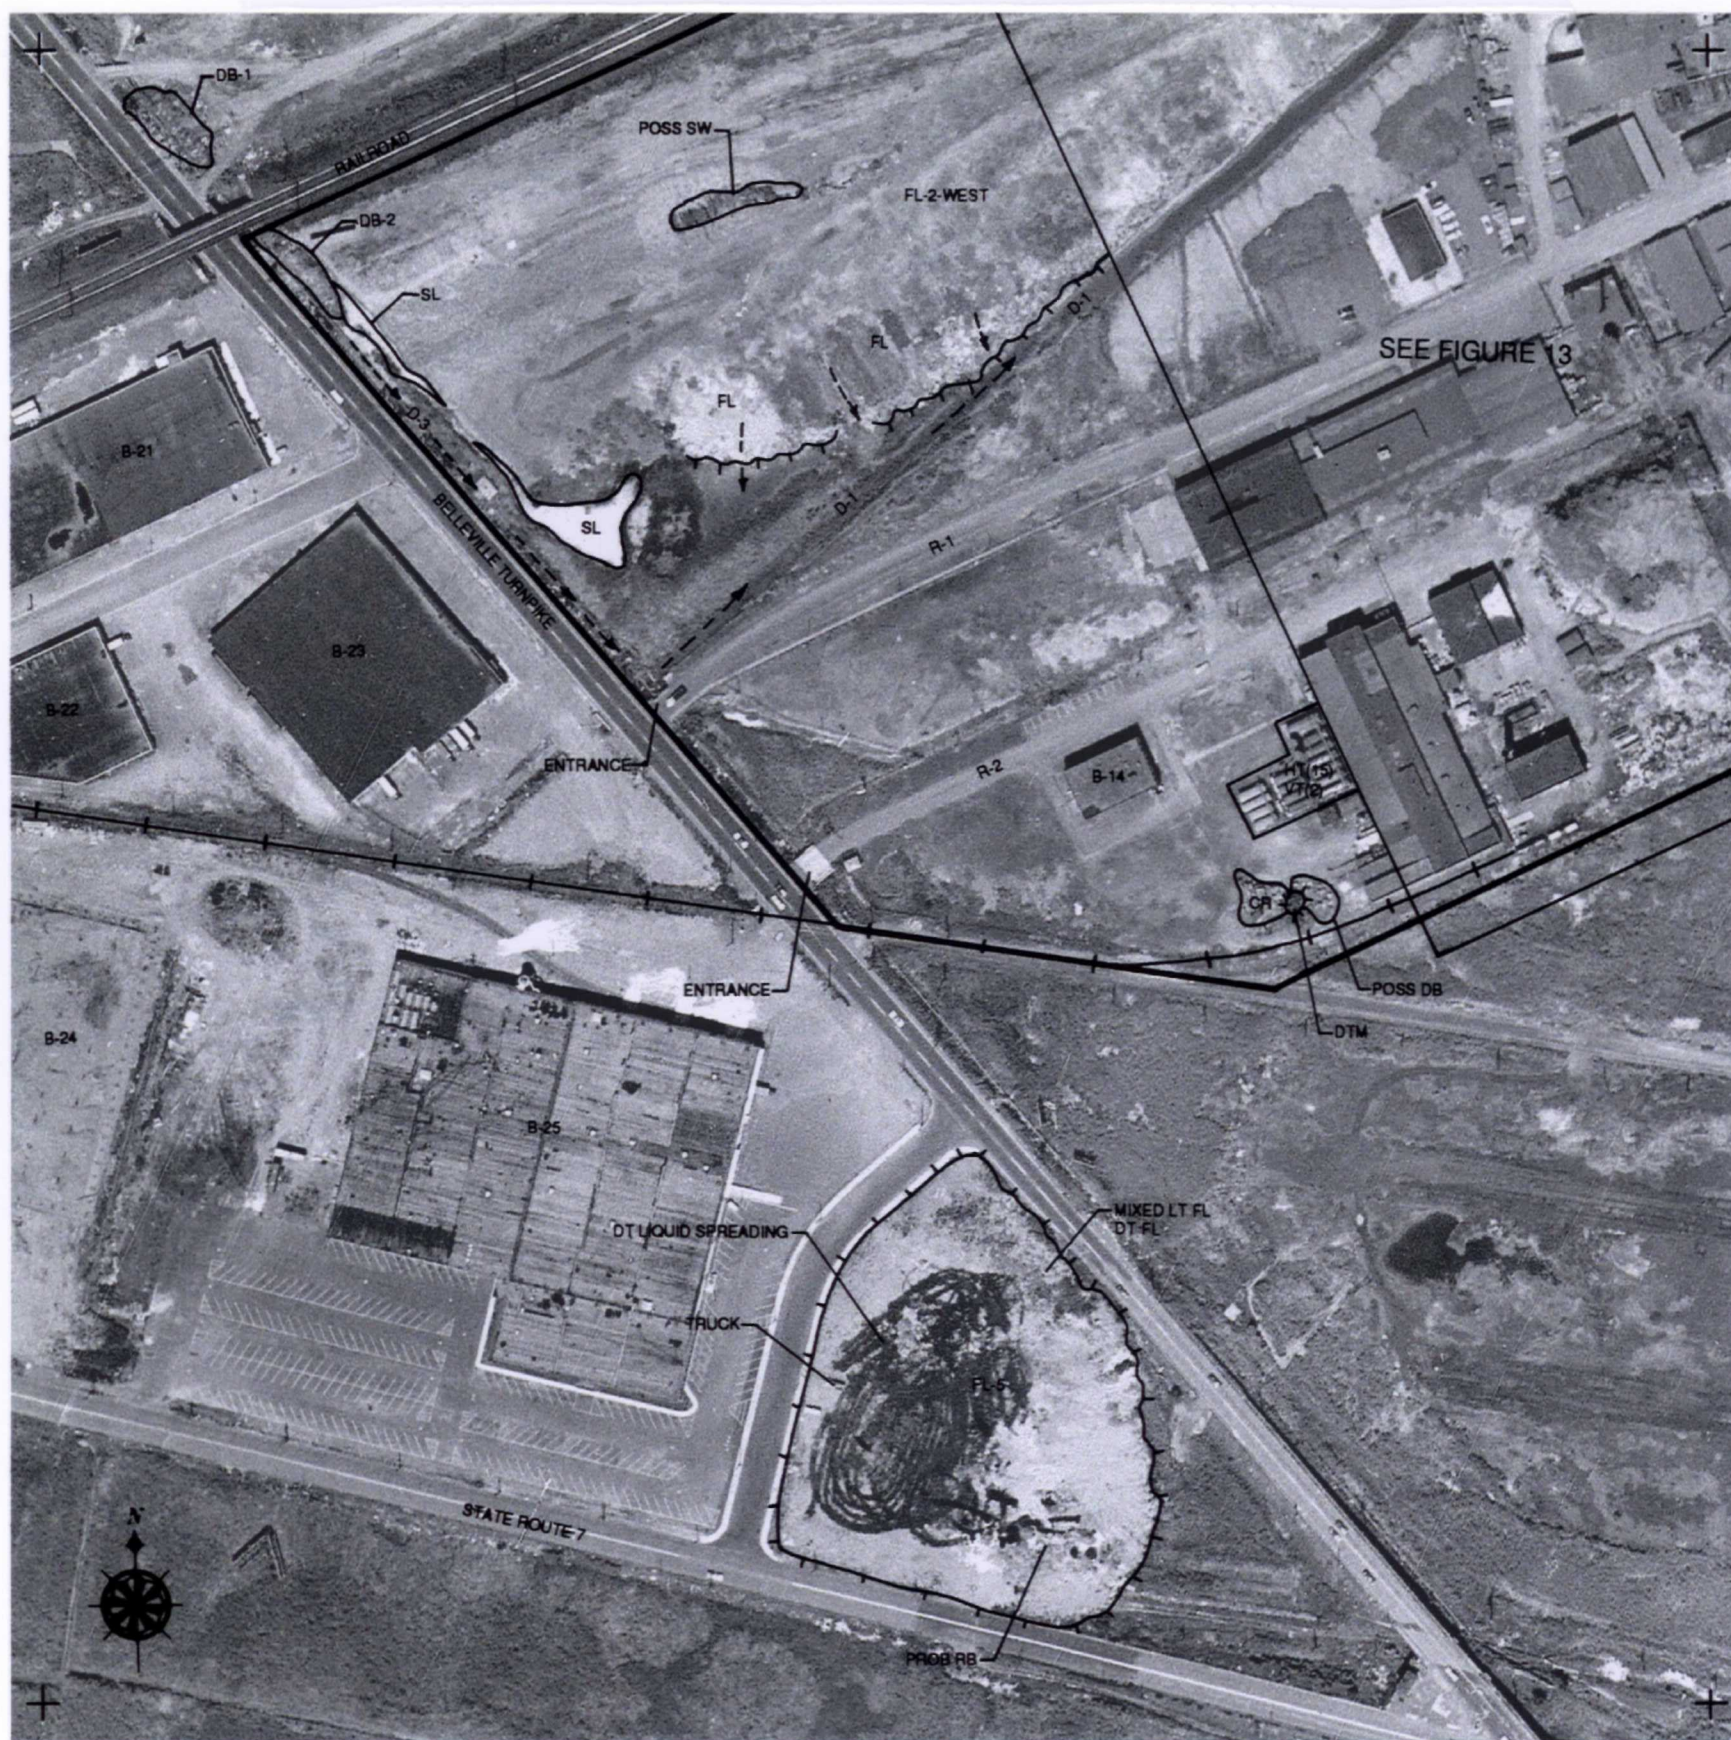
Figure 14. Standard Chlorine site, August 11, 1968. Approximate scale 1:2,460.

Off-site, several large commercial/industrial buildings (B-21 through B-25) have been erected on the west side of the Belleville Turnpike. South of the site a large fill area (FL-5) is visible near the intersection of Belleville Turnpike and State Route 7. Mixed light- and dark-toned fill, probable construction rubble (RB), and dark-toned liquid spreading patterns are observed in this area.

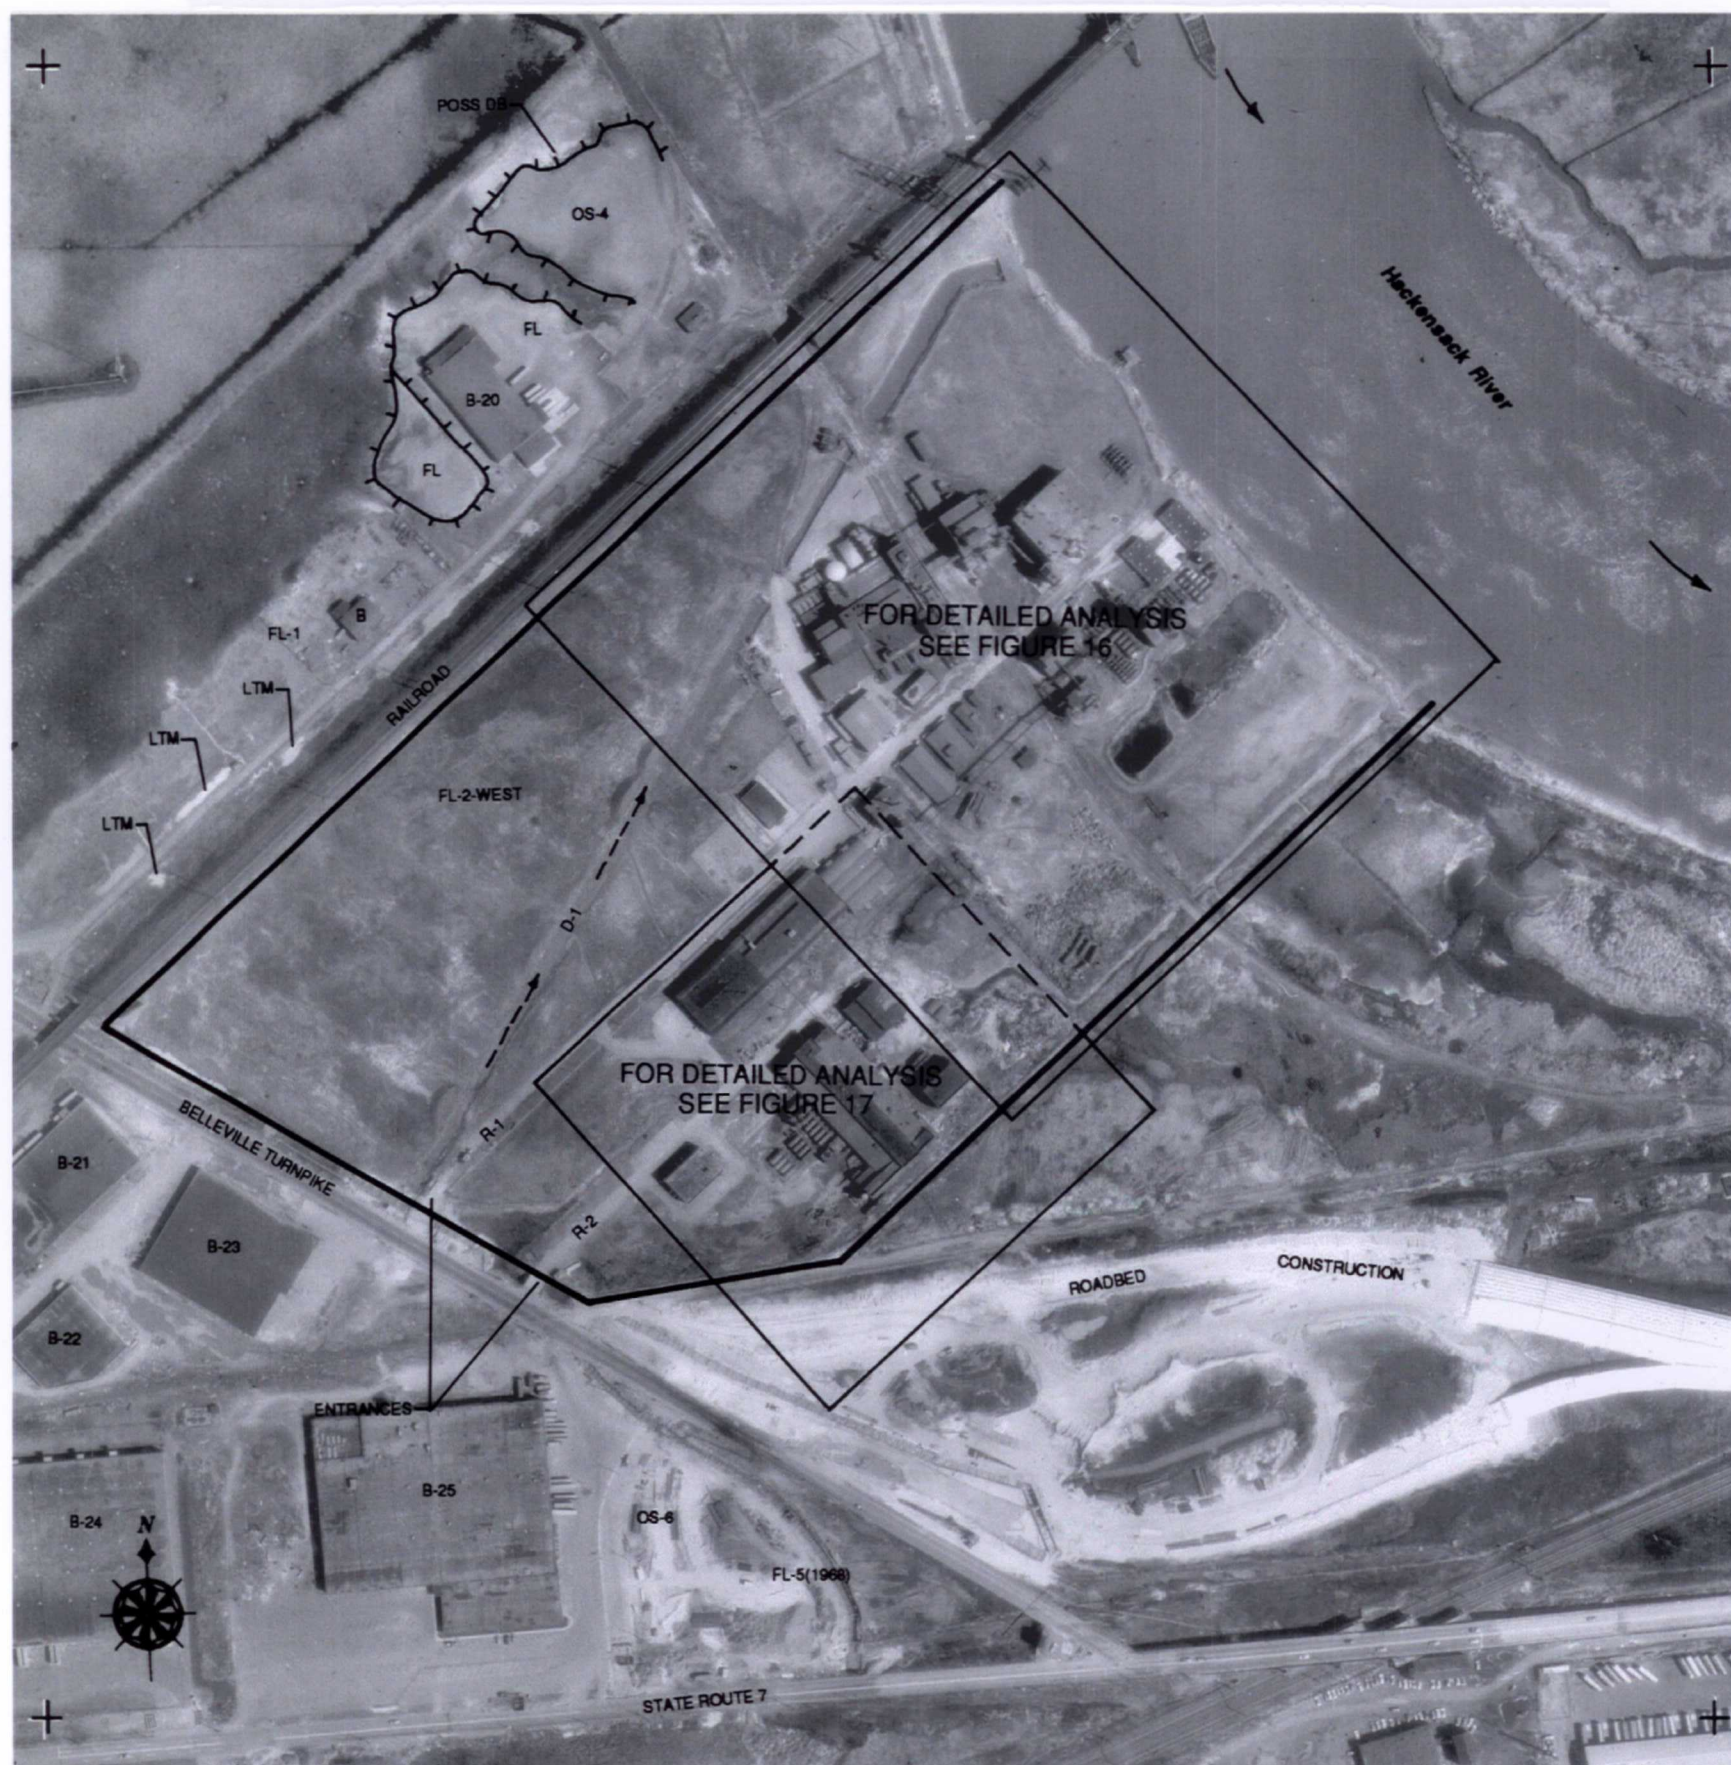
Roadbed construction activity is observed south of the site. This activity will no longer be discussed unless waste disposal activity is noted or river channel modification is observed.
